LBT PROJECT
2x8,4m TELESCOPE

Doc.No. : 687s002
Issue : a
Date : 30 Jan 2009

LBT672 On-axis Wavefront sensor #2
Lab Acceptance Test Report

This document describes test results from the Lab Acceptance Test of “W” unit #2, performed at Arcetri Observatory on Jan 27-29, 2009.

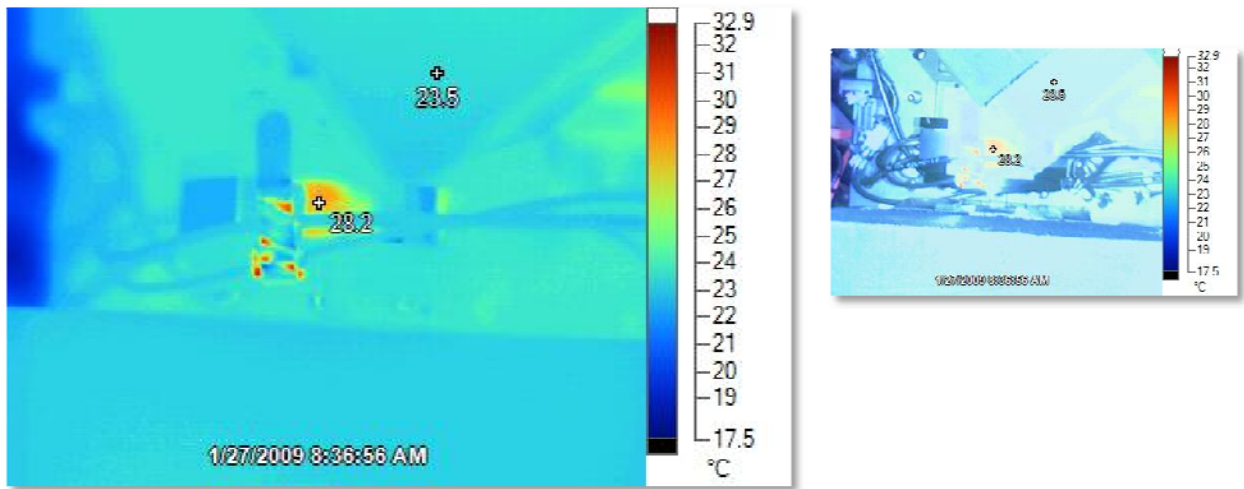
Figure 4: Tip-Tilt stage

Figure 4 shows a close-up of the tip-tilt stage actuator. Maximum surface temperature is 28.2 degrees. Since this is a small area, it was not deemed critical.

AI: Investigate reason for warm tip-tilt stage actuator.

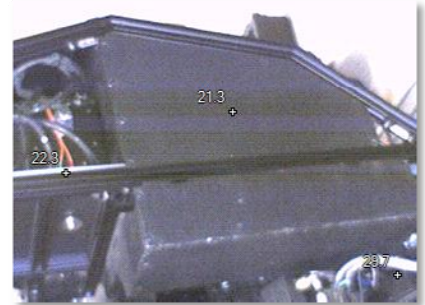
Figure 7: Thermal image of WFS Electronics box 2

The two main electronics enclosures (Box 1 and Box 2) are water cooled and thermally insulated. This is very efficient and no increased surface temperatures were observed. Note the warm stage motor in the lower right corner of Figure 7.

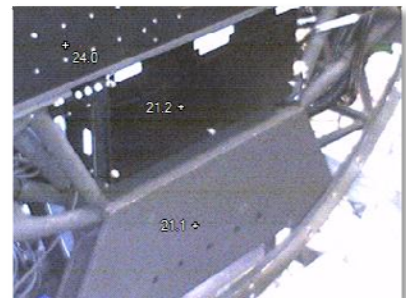
Figure 8: Thermal image of WFS Electronics box 4

The camera lens electronics were integrated into a new enclosure (Box 4, center of Figure 8). The box is water cooled and thermally insulated. The warm surface on the upper right is a part of the “flower pot”.

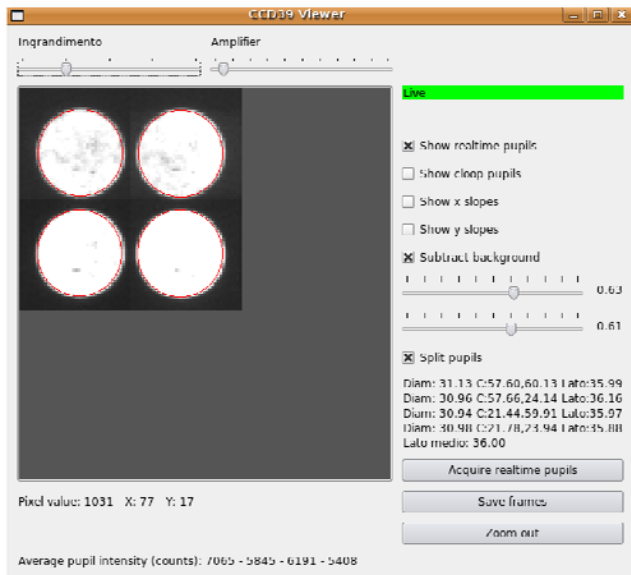
Measurement was performed according to Section 4 of [RD2], with the goal to verify pupil diameters to 30 +/-0.1 pixels on the WFS CCD, and pupil center distances to 36 +/-0.1 pixels.

Figure 9: Pupil configuration

Conclusion: Pupil diameters (average) and center distances are marginally out of specification. Center distance can be adjusted independently from pupil diameter by adjusting focus of the WFS board.

AI: Adjust focus on WFS board to correct pupil image geometry

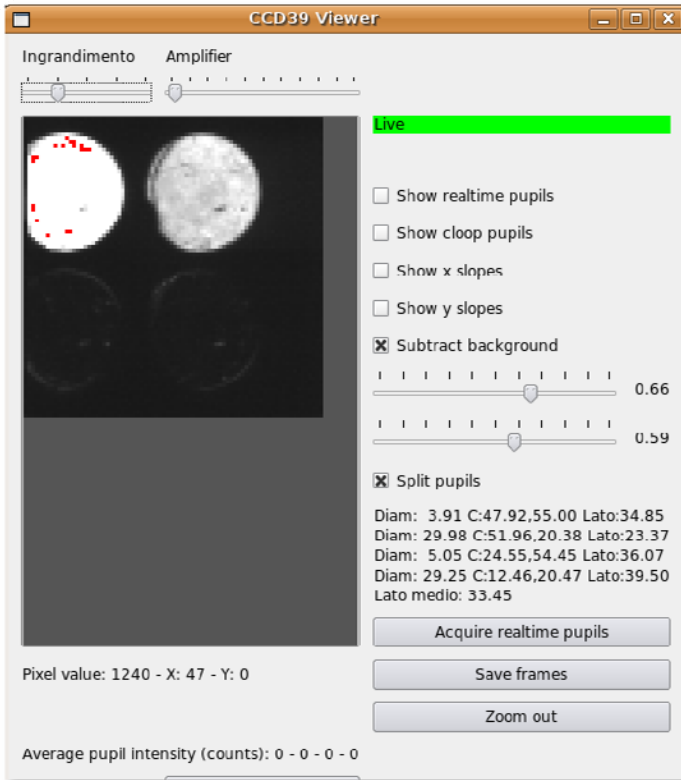
<i>Temperature</i>	<i>Observations</i>
+10C	Full system test before test. System fully functional.
0C	<ul style="list-style-type: none"> • Functional test OK • Some vignetting visible on pupils (see Figure 10). Cube angle was re-adjusted by 0.4 degrees which removed the vignetting. • Re-rotator got stuck moving in negative direction. Fixed by reducing re-rotator rotation speed from 12 to 4 units.
-10	<ul style="list-style-type: none"> • Functional test OK • Some vignetting visible on pupils. Cube angle was re-adjusted by 0.7 degrees which removed the vignetting. • Re-rotator got stuck moving in negative direction. Fixed by reducing re-rotator rotation speed from 12 to 4 units. • Camera lens driver Y switched off unexpectedly (restarted) • BCU47 Ethernet shut down unexpectedly (restarted) • Misalignment 5 pixels visible on pupils. See Figure 11. • Camera lens range 98um (spec 100um)
-20C	<ul style="list-style-type: none"> • Functional test OK • Some vignetting visible on pupils. Cube angle was re-adjusted by 0.8 degrees which removed the vignetting. • Re-rotator got stuck moving in negative direction. Fixed by reducing re-rotator rotation speed from 12 to 4 units. • BCU47 Ethernet shut down unexpectedly (restarted) • BCU39 shut down unexpectedly (restarted) • Misalignment 5 pixels visible on pupils • Camera lens driver Y switched off unexpectedly.

Figure 10: Vignetted pupils at 0C

- AI: Investigate reason for unreliable function of camera lens driver at low temperatures**
- AI: Investigate reason for unreliable function of BCU39 and BCU47 at low temperatures**
- AI: Investigate reason for optical misalignment at low temperatures**
